Test Intention:

In this test we want to investigate the lifespan of our CF887.15.15.02.01 in an e-chain with a 150mm radius.

Series / No: CF887

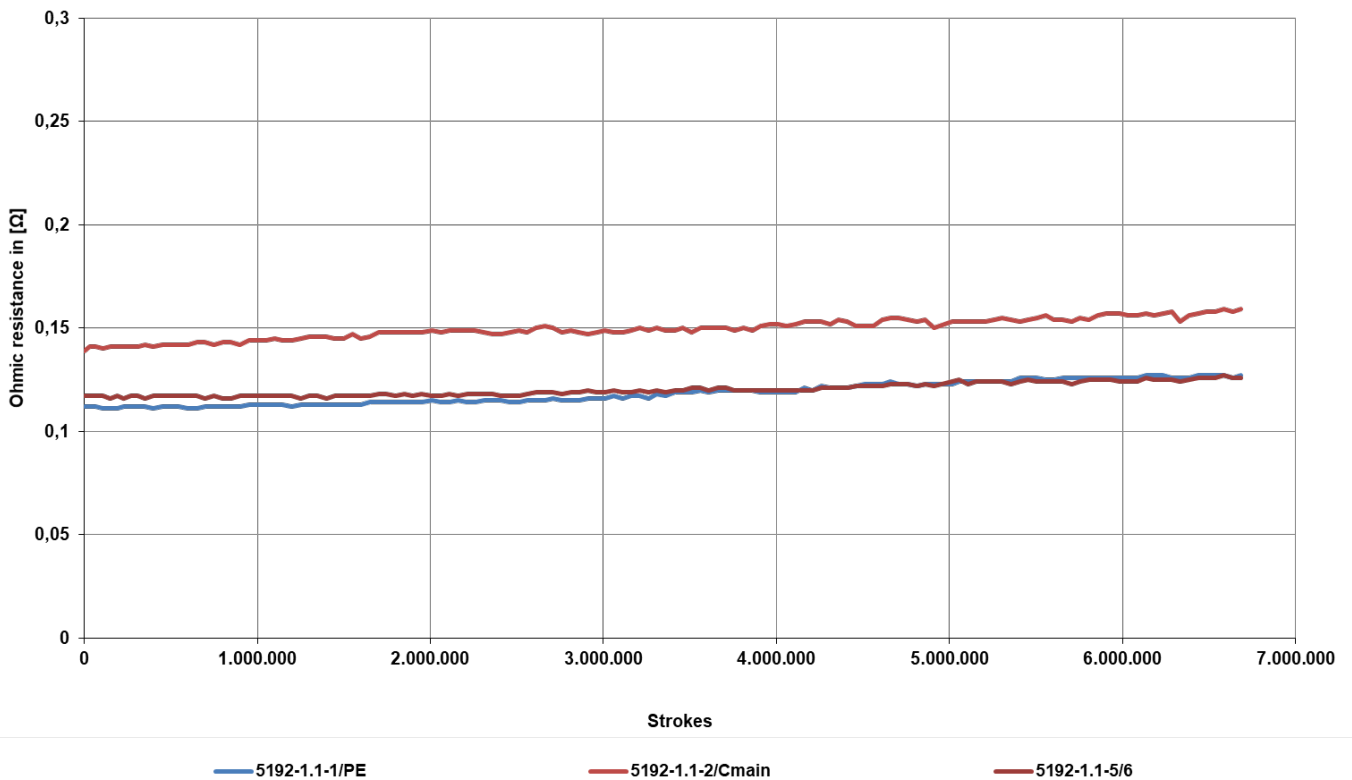
Trend of the ohmic resistances at 25°C

The following diagram shows the trend of the ohmic resistances during the test:

At the 13.03.2017 we started the test 5192 at a counter reading of 11.424.955 , we will measure the ohmic resistance regularly through AutΩMeS.

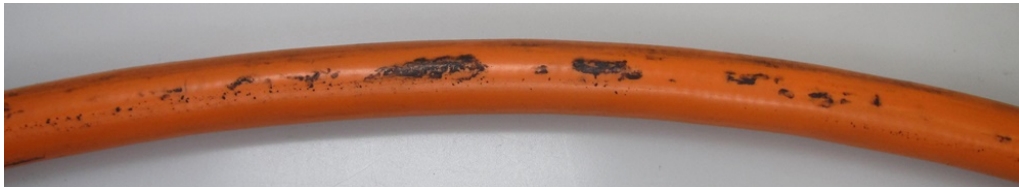
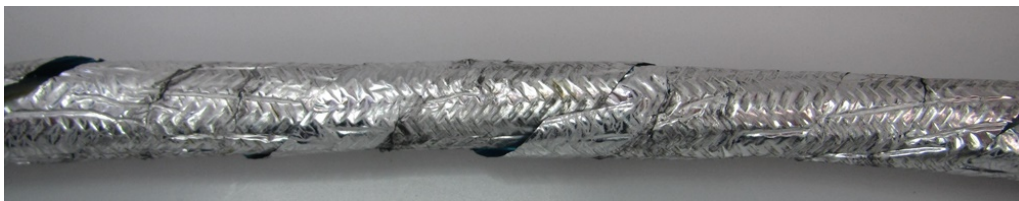
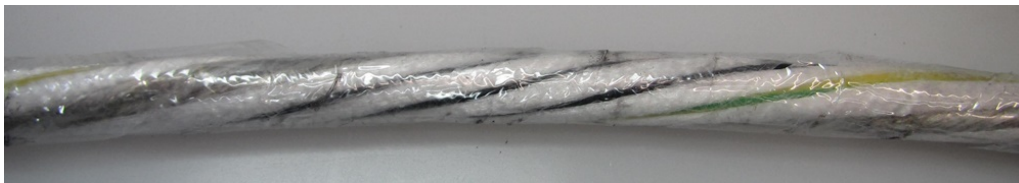
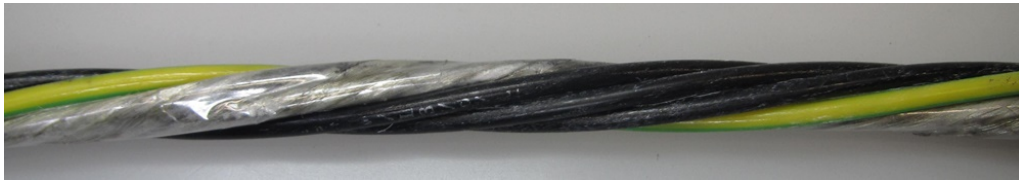
The condition of the cable no. 1.1 (CF887.15.15.02.01) after 6.684.376 strokes

Strokes	6.684.376
Condition outer jacket	O.K.
Condition overall shielding	Single broken wires
Condition foil banding	O.K.
Condition filler	O.K.
Condition centre element	O.K.
Power cores	
Condition core insulation	O.K.
Condition conductor	O.K.
Element bundle	
Condition element banding	O.K.
Condition element shielding	Single broken wires
Condition core insulation	O.K.
Condition conductor	O.K.

At the 26.10.2017 we demounted the cable no. 1.1 after 6.684.376 strokes, to check the condition of the cable elements.
